BUTTERNUT CREEK WATERSHED MANAGEMENT PLAN (DRAFT 08.31.21)

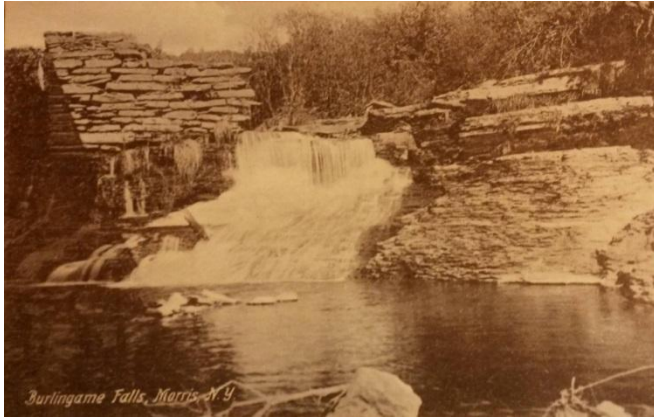
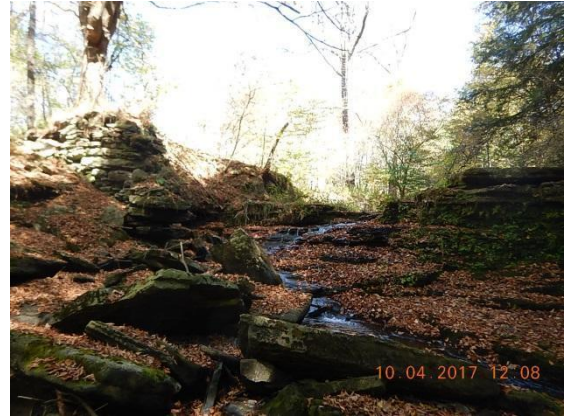
Figure 13. Photos of dam remnants on Aldrich Creek at Burlingame Falls (listed as a Cider Mill in Beers et al. 1968). Photo on left date unknown, courtesy of Morris Historical Society Postcard Collection. Photo on right from same location October 4, 2017 (photo credits OCSWCD).

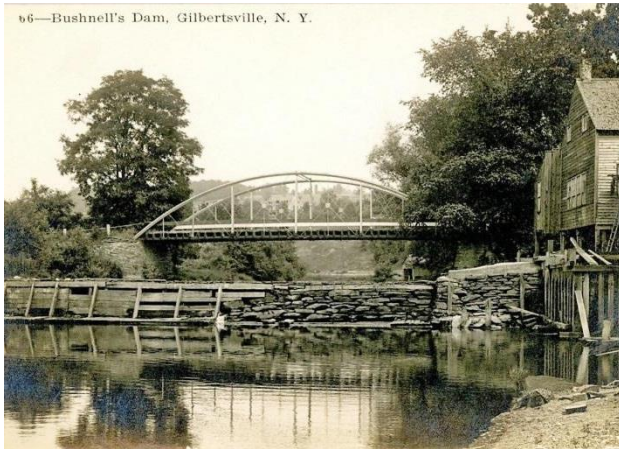
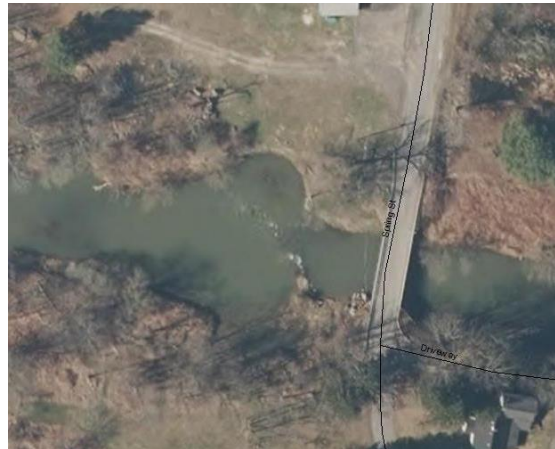
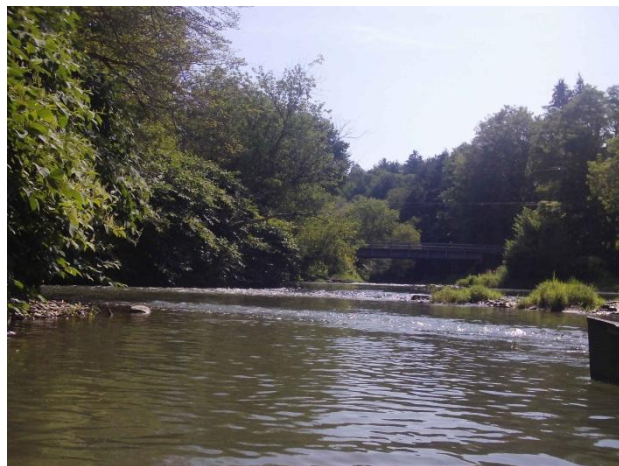
Figure 14. Bushnell’s Dam/Bridge at Spring St in Gilbertsville, NY. Upper left date unknown (Bridgehunter 2018), Upper right – 2014 leaf off aerial imagery, Lower left – looking upstream from downstream of current Spring St bridge, Lower right – looking downstream from Spring St bridge (photo credits OCSWCD taken on 8/9/2017).

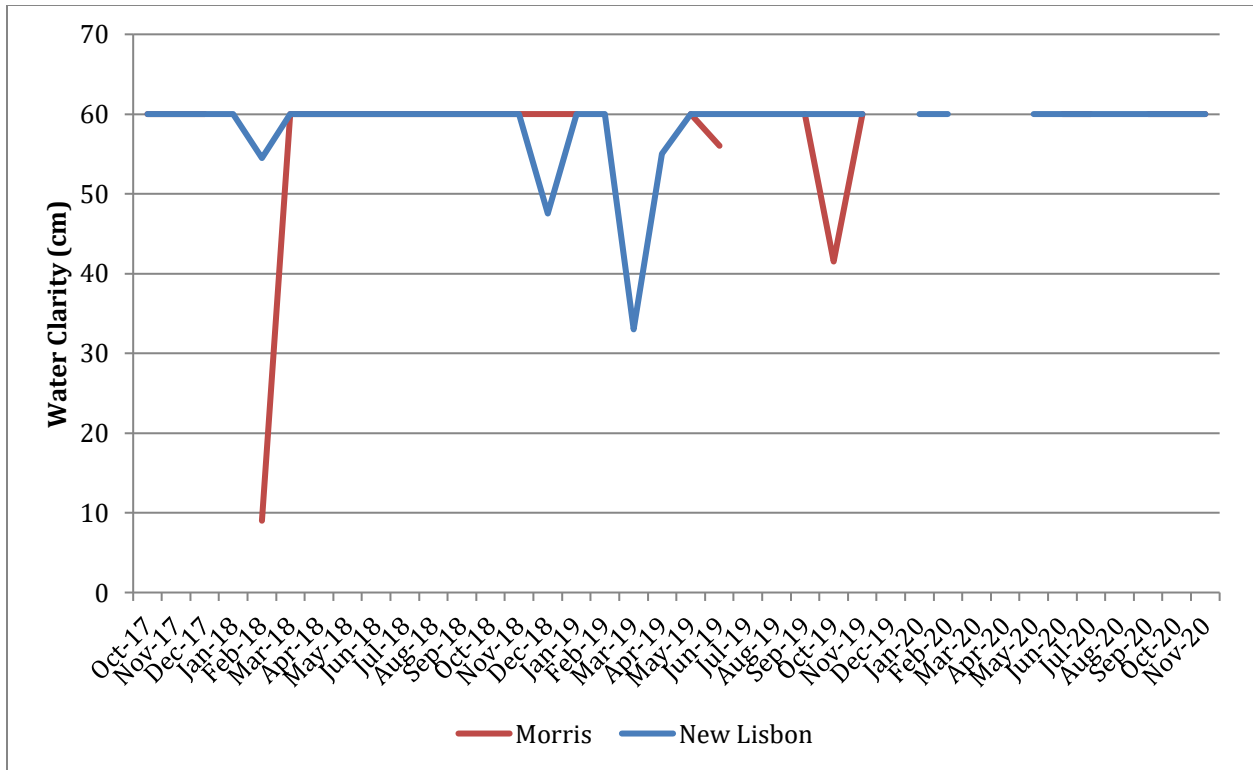
Figure 25: Water clarity measurements for Butternut Creek from October 2017 through May 2020.

Water clarity indicates the ability of light to penetrate the water column (OCCA 2020). The amount of light penetrating to the bottom of the water column is important for algae and aquatic plants to be able to carry out photosynthesis. For both sites water clarity remained high at the maximum recording value of 60 cm with a few exceptions likely due to rain events increasing the amount of sediment suspended in the water (Figure 25). The Morris site had a greater number of lower readings and a lower monthly mean indicating more sediment is accumulated as water flows downstream in the watershed (Table 15). Compared to the other sites in the watershed the Morris site had the lowest water clarity reading of all sites of 9 cm in February 2018 but was not consistently the lowest overall (OCCA 2020). Overall, the sites sampled indicate high water clarity in Butternut Creek.

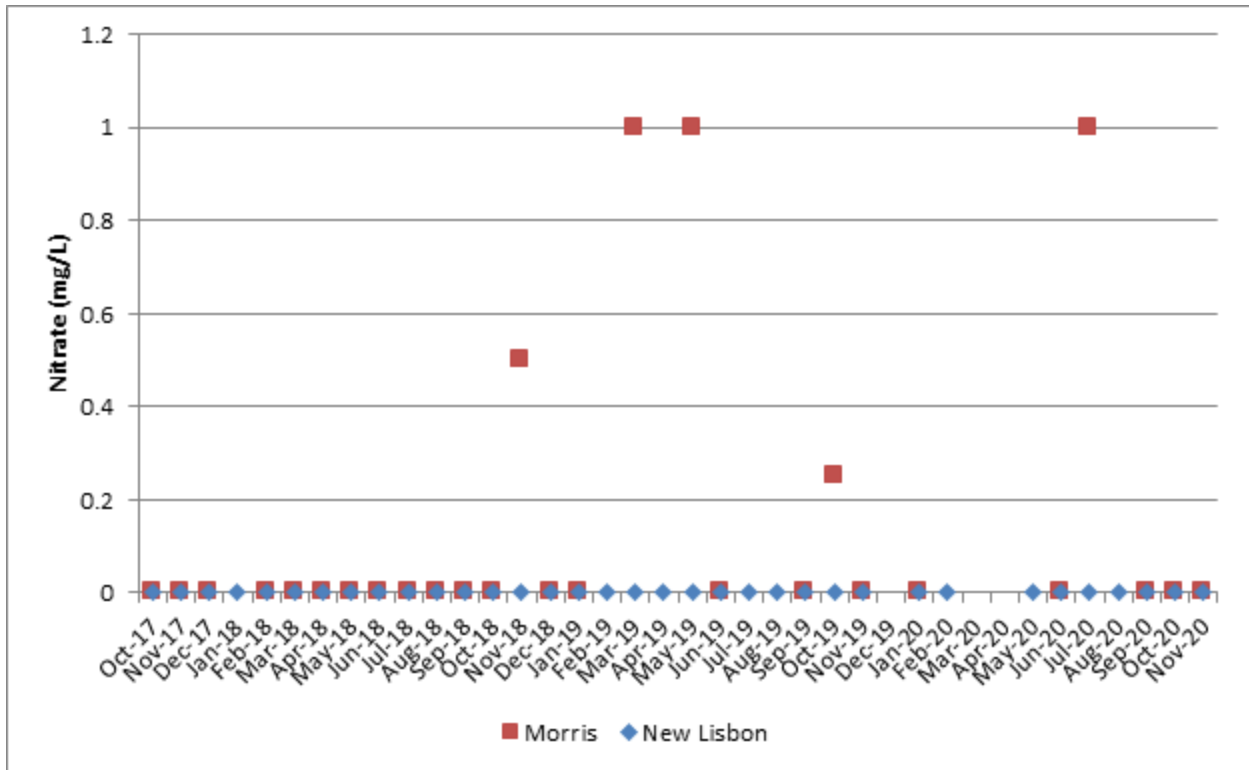
Figure 28. Nitrate measurements for Butternut Creek from October 2017 through May 2020.

Nutrient levels (nitrate and orthophosphate) can be indicative measures of nonpoint source pollution caused by agricultural activities in a watershed. These can be important data to assess when trying to target agricultural best management practices in the watershed. Nitrate levels at the New Lisbon site were consistently low throughout the sample period. The Morris site nitrate levels remained low overall but had higher readings in spring 2019 and fall 2018 and 2019 (Table 15, Figure 28). The Morris site is one of five sites throughout the Otsego County wide sampling that showed elevated levels (OCCA 2020). Samples of orthophosphate at the two Butternut Creek locations varied throughout the year without exhibiting an overall trend (Figure 29). Levels at both sites remained below 0.08 mg/L. In 2017/2018 orthophosphate levels were increased at the New Lisbon site but then readings in 2019 remained low during same months. The New Lisbon site had some of the highest orthophosphate levels for 2017/2018 compared to the other sites in Otsego County. Alternatively, orthophosphate at the Morris site remained low in 2018 and then increased at times in 2019 and 2020. Nitrate and orthophosphate are nutrients that can be indicators of degraded water quality conditions. Increased levels of these nutrients from agriculture and lawn maintenance cause increased algal growth (OCCA 2020).

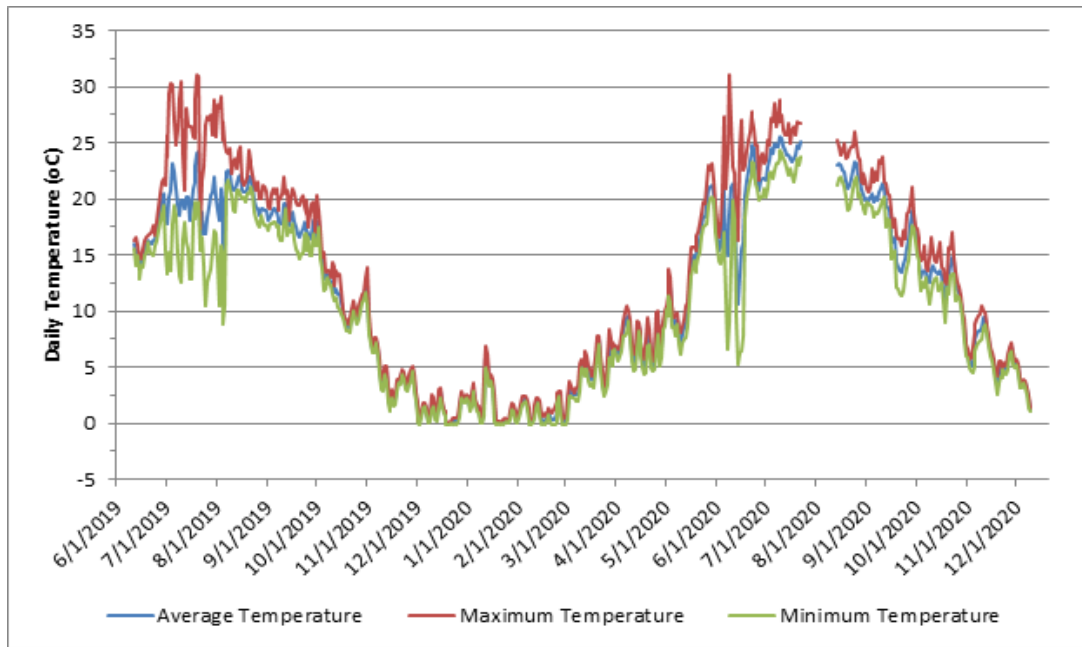
Figure 30. Water temperature measurements for Butternut Creek at Flatiron Bridge from June 11, 2019 through December 9, 2020 (SRBC 2020).

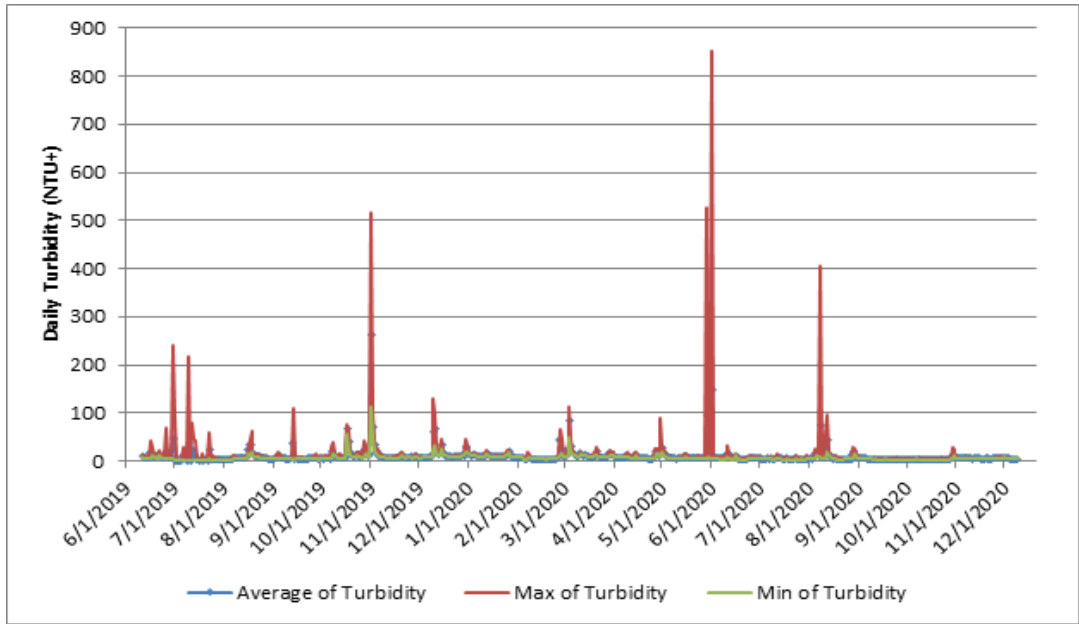
Figure 32. Turbidity measurements for Butternut Creek at Flatiron Bridge from June 11, 2019 through December 9, 2020 (SRBC 2020).

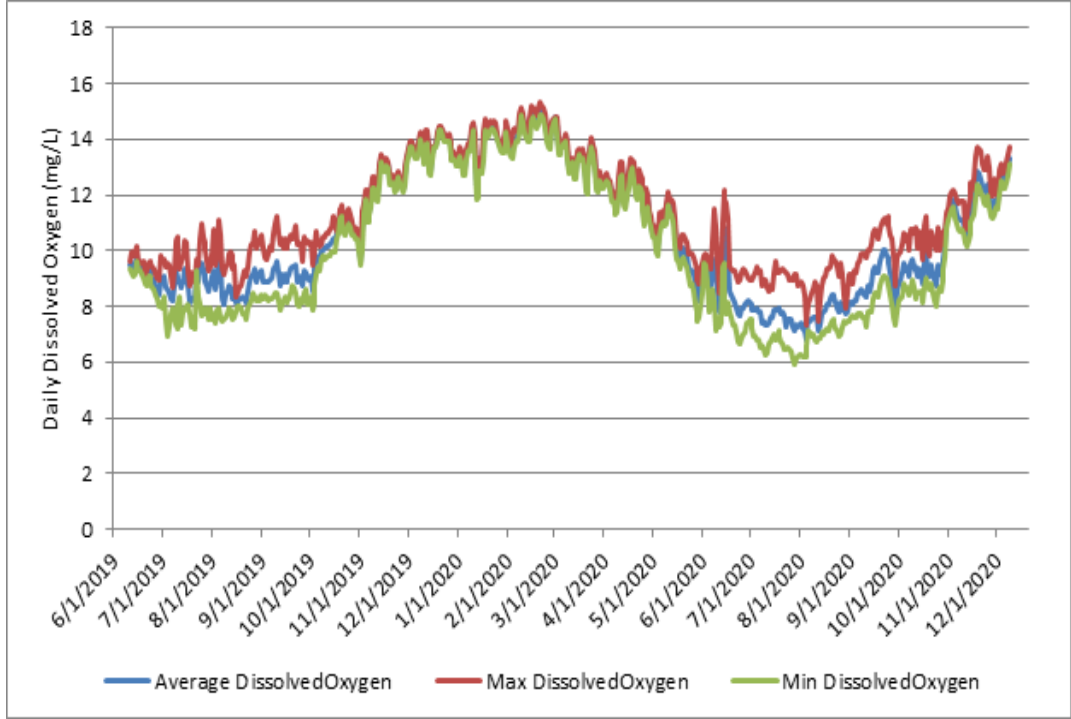
Figure 33. Dissolved oxygen measurements for Butternut Creek at Flatiron Bridge from June 11, 2019 through December 9, 2020 (SRBC 2020).

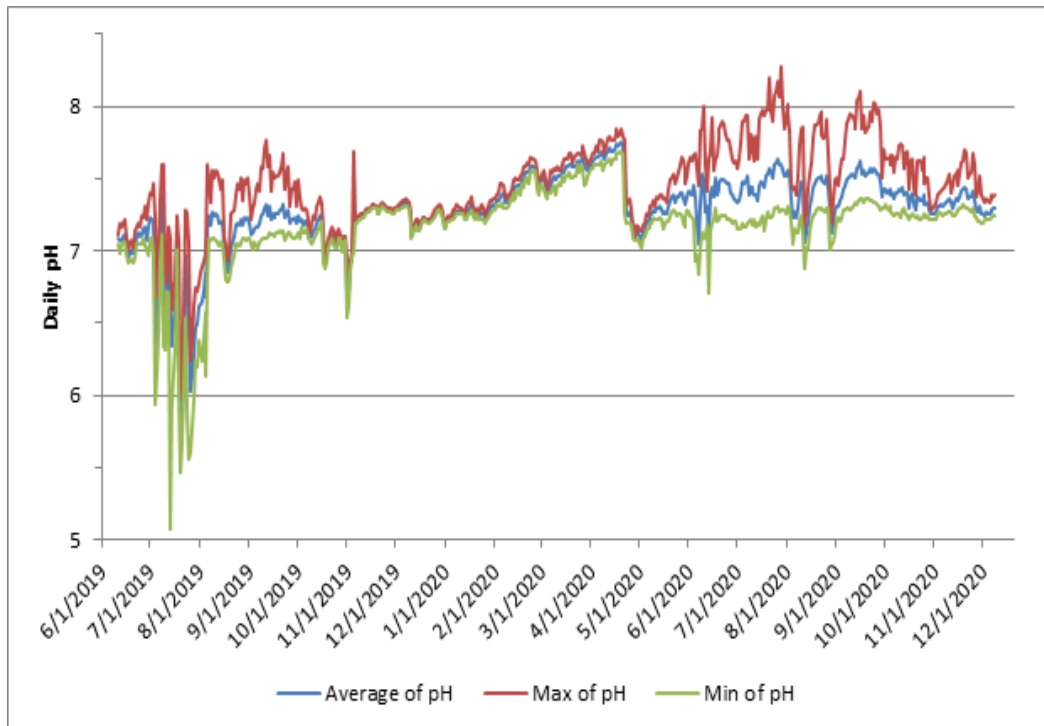
Figure 34. pH measurements for Butternut Creek at Flatiron Bridge from June 11, 2019 through December 9, 2020 (SRBC 2020).

Readings of pH at the Flatiron Bridge location mostly hovered between seven and eight throughout the year with a few exceptions (Figure 34). In July of 2019, the pH was consistently below seven and approached five at one point but in July of 2020 remained over seven (Figure 34).
